Corrosion in air conditioning systems – a growing problem

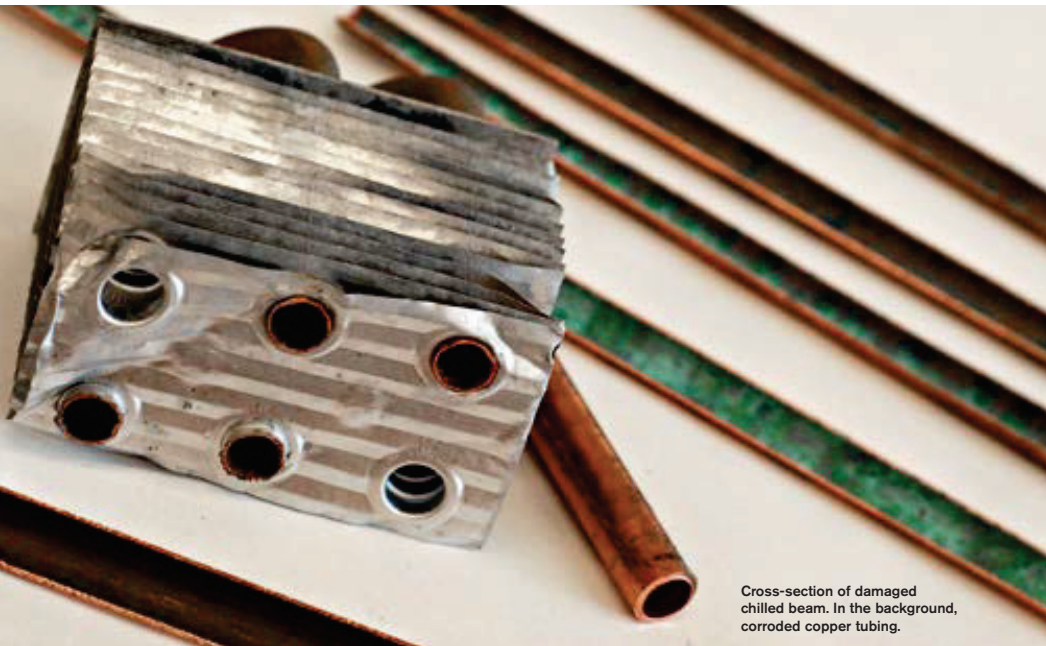
Cross-section of damaged chilled beam. In the background, corroded copper tubing.

Often, the instances of corrosion damage that Swerea KIMAB encounters, have several causes. One common scenario is when oxygen leaks into the system, causing cast iron or steel pumps in sub-systems to corrode. The presence of oxygen is a precondition for corrosion to occur. Ferrous/ferric corrosion products are carried in the piping, leading to problems in the form of either under deposit corrosion or bimetallic corrosion. Ferrous/ferric corrosion products are more noble than copper; therefore, a galvanic cell forms, with

copper as the anode. Consequently, local corrosive attacks occur in the copper tubing, instead of more evenly distributed general corrosion.

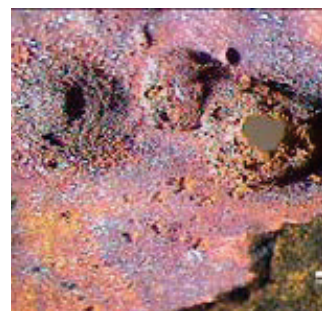
Beautiful but undesirable. Electron-microscope image of copper corrosion products.
